**NPDES
Compliance Inspection Report**

Udder Pride Dairy, LLC

Lynden, Washington

March 30, 2010

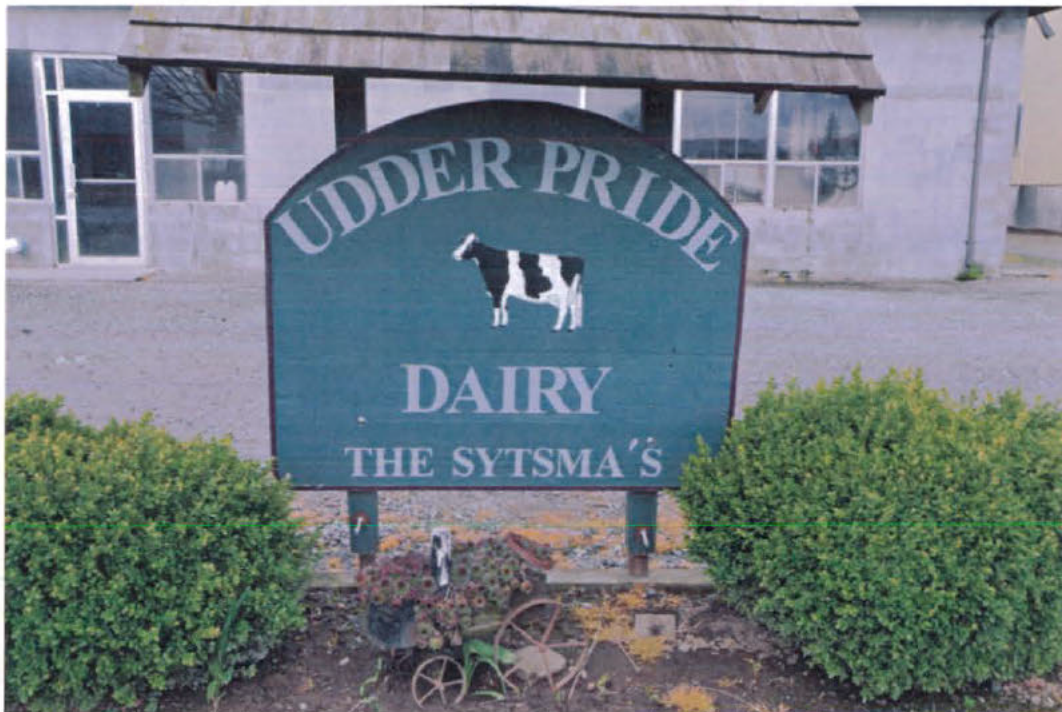
This is a dairy facility that Alan Sytsma has been operating for approximately 9 years, since 2001 (photo 1). Previous to 2001, he operated the dairy with (b) (6) the original owner.

Photo 1. Udder Pride Dairy sign.

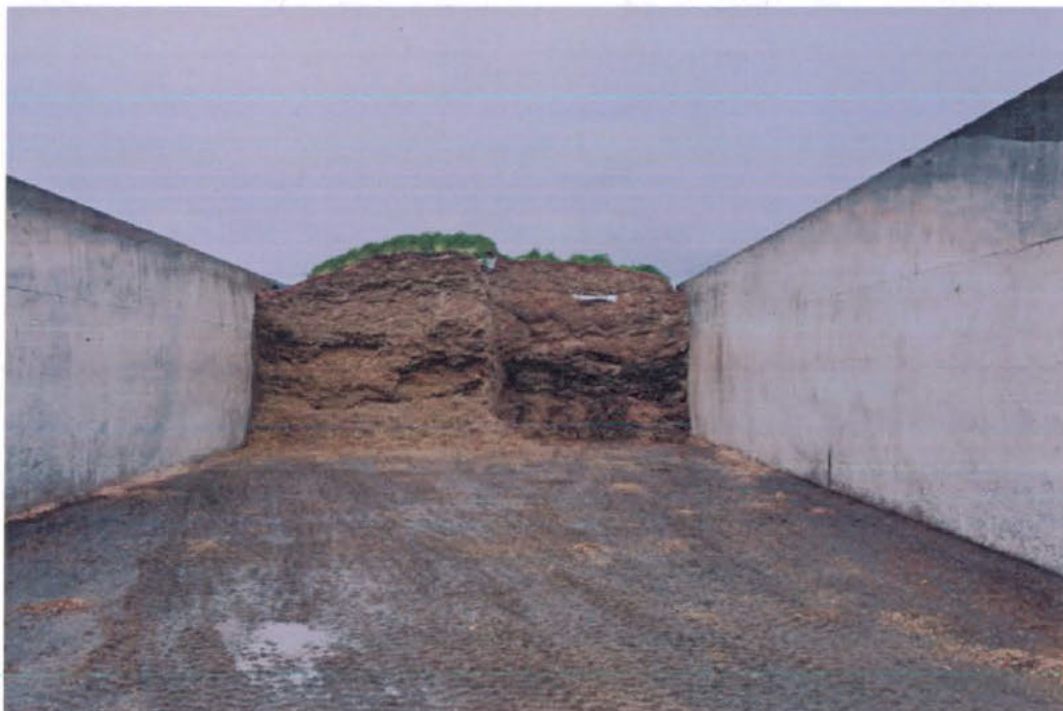
The feed was stored in bunkers and was covered with either a tarp or a roof (photo 2).

Photo 2. Silage storage bunker, covered with a tarp and grass.

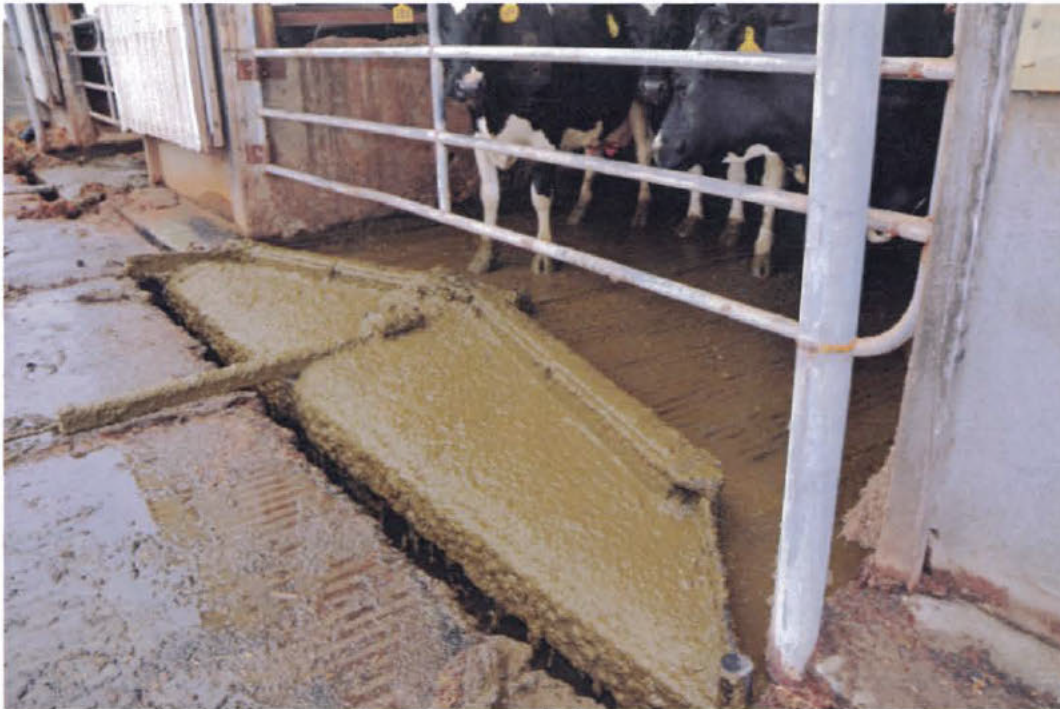
Waste from the barns is scraped into the below-ground storage tank using tractors and automatic scrapers and is then pumped to a solids separator (photos 3 – 6). Liquid waste is routed from the solids separator into the first lagoon (photo 7).

Photo 3. Automatic barn scraper.

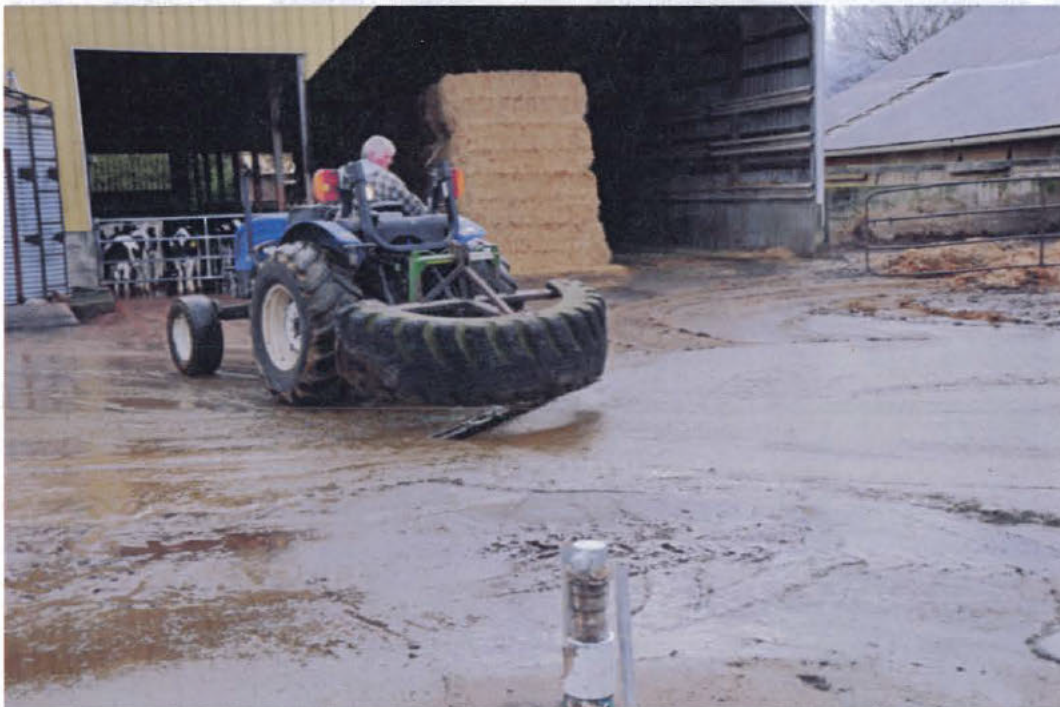
Photo 4. Barn waste being scraped into a slot drain.

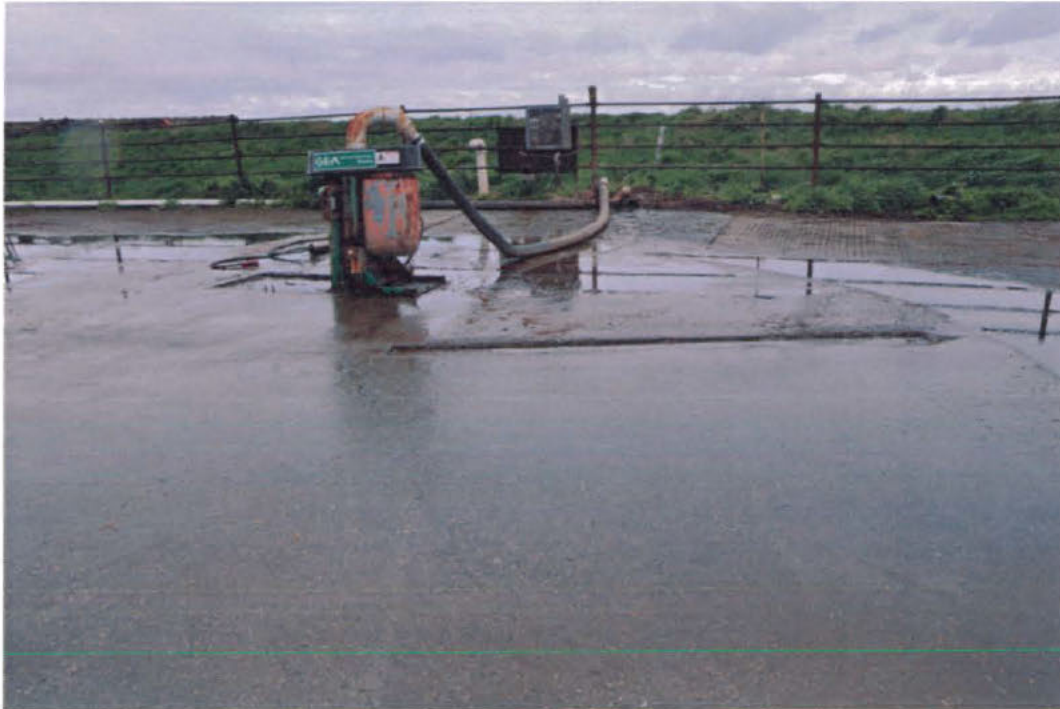
Photo 5. Below-ground storage tank pump to solids separator.

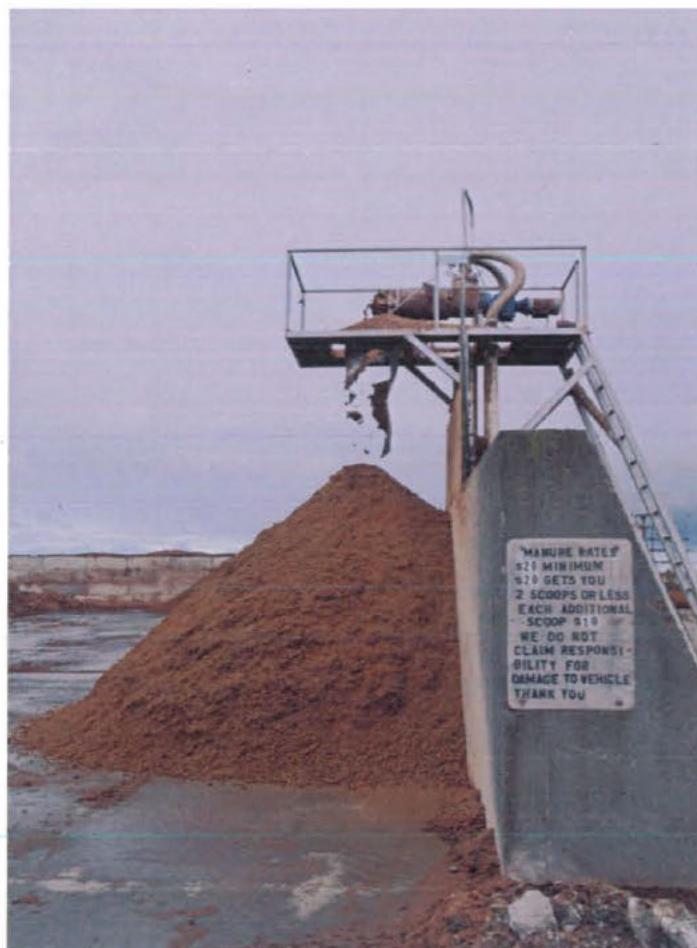
Photo 6. Solids separator.

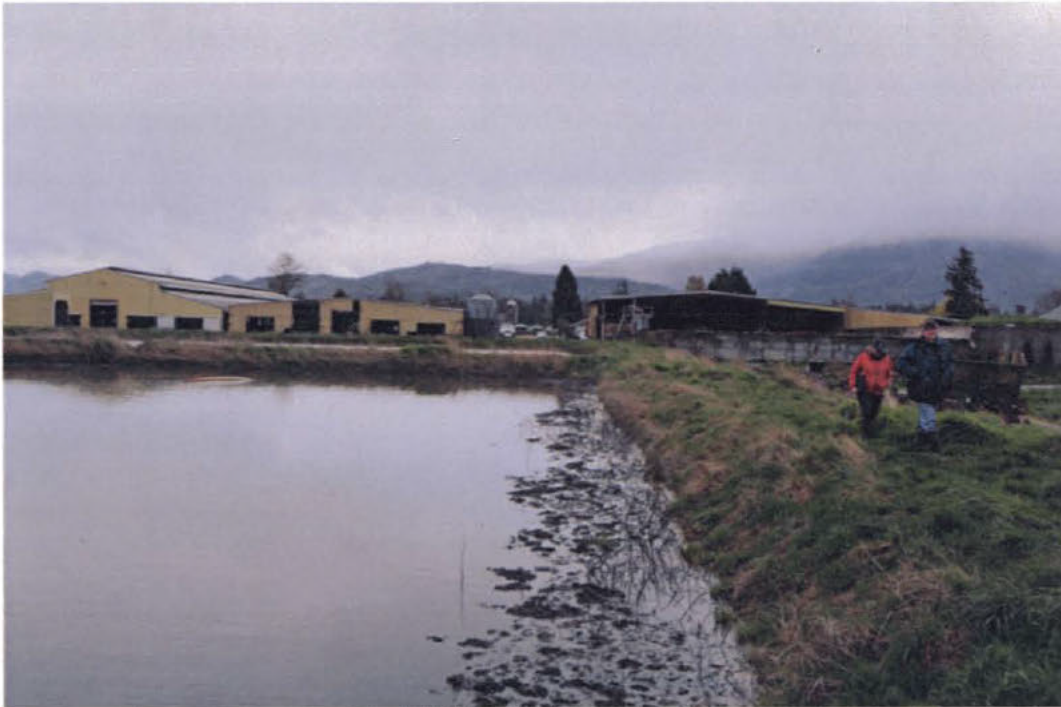
Photo 7. Liquid storage lagoon.
